AEROSPACE EMERGENCY RESCUE AND MISHAP RESPONSE INFORMATION (EMERGENCY SERVICES) THIS PUBLICATION SUPPLEMENTS TO 00-105E-9 REVISION 8, DATED 30 SEPTEMBER 2002, LOCATED AT WE SITE:http://www.robins.af.mil/logistics/LGEDA/Documents/to00-105e-9.htm. DISTRIBUTION STATEMENT - Approved for public release; distribution unlimited. COMMANDERS ARE RESPONSIBLE FOR BRINGING THIS SUPPLEMENT TO THE ATTENTION OF ALL AFFECTED AIR FORCE PERSONNEL. PUBLISHED UNDER AUTHORITY OF THE SECRETARY OF THE AIR FORCE 24 November 200: PURPOSE. This supplement provides instructions for update of TO 00-105E-9 Revision 8, dated 30 September 2002, affecting Chapter 8 USAF Fighter Aircraft. This update adds new information regarding the F/A-22 procedures with information regarding associated hazards provided by the SPO. This supplement supercedes SS-5 dated 27 August 2003. INSTRUCTIONS. a. This information, if it applies to your operation, can be downloaded and printed from this web site by the end user. Use the most current Adobe Reader for this function. This software is free and can be downloaded from Adobe.com at their web site. PDF files should be downloaded with the Reader running on your PC to reduce download

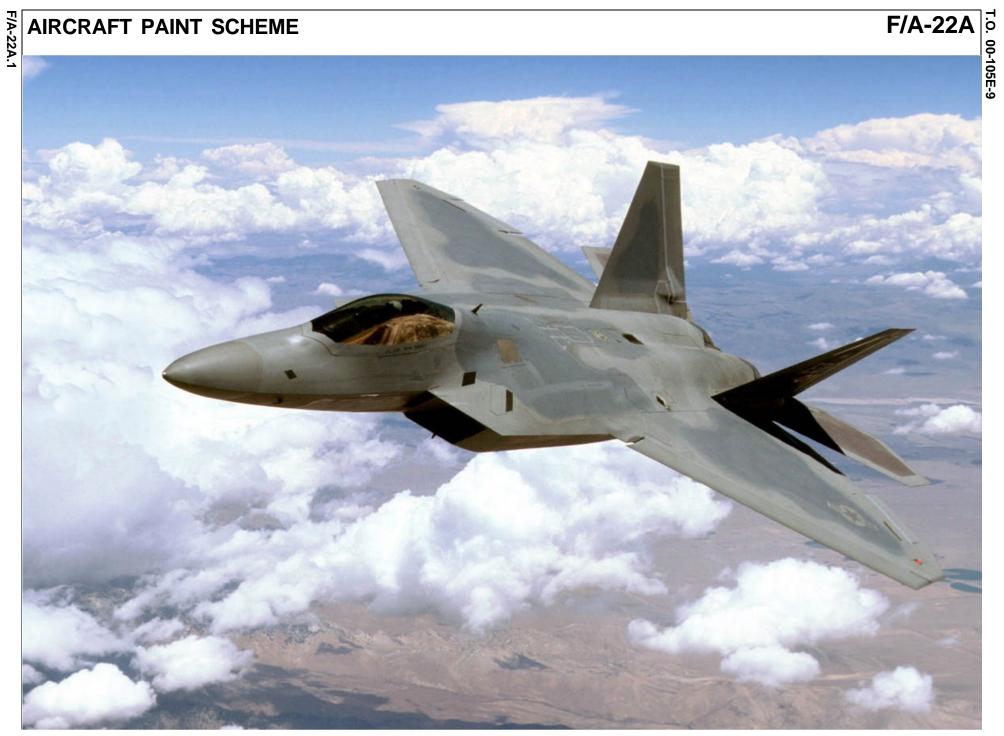
F/A-22A. 2

Height dimensions are typical for an aircraft fully serviced and with internal fuel.

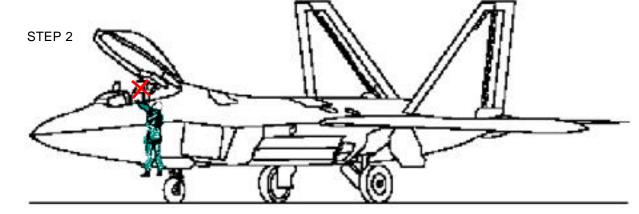
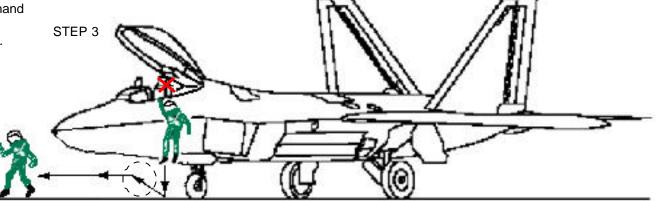
1. AIRCREW EGRESS

Do not use any part of the ACES II ejection seat as a hand held area while climbing out of aircraft, most notably the pitot tubes located at top of seat. Inadvertant actuation of ejection seat components could have devastating and deadly results. This also includes the canopy jettison handle on the left console.

- a. STEP 1. Climb over least dangerous side of aircraft (i.e. no smoke, fire or running engine), grasping canopy rail or sill with both hands while lowering legs down side of aircraft. Watch for potential snagging of life support equipment while climbing over canopy rail or sill cams.
- b. STEP 2. Extend body, with both hands, while still holding onto canopy rail or sill.
- c. STEP 3. Release forward most hand from canopy rail or sill and rotate body to the facing away position from the engine intake. Release last hand from canopy rail or sill. Prepare to perform a Parachute Landing Fall upon hitting the ground.
